The Breakup of *Titanic*

**A Progress Report from the
Marine Forensics Panel (SD-7)**

A Progress Report from the Marine Forensics Panel (SD-7)

Roy F. Mengot, (V) UGS; Richard T. Woytowich, (M) New York City College of Technology

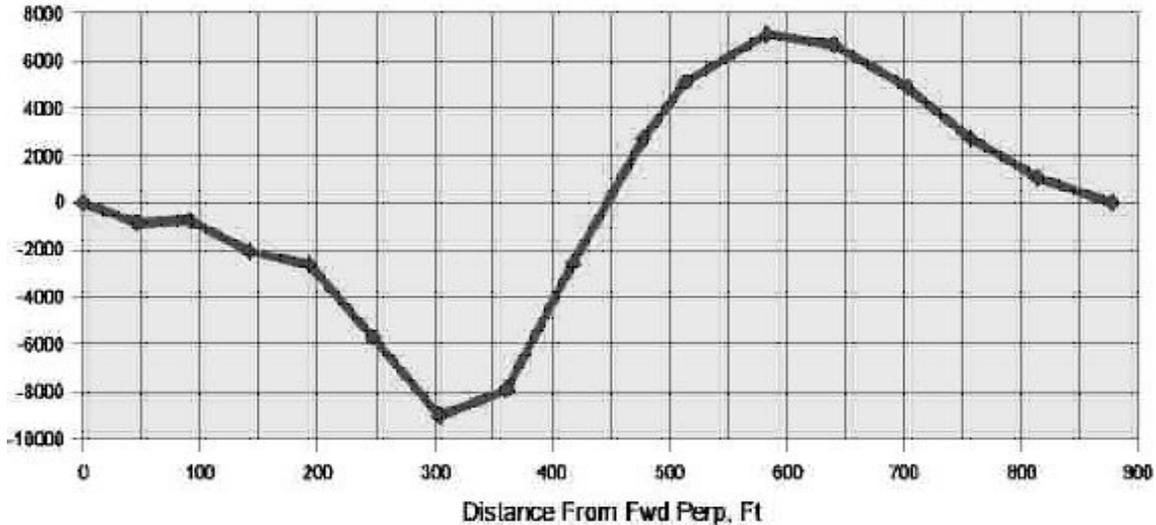
Figure 1 – Shear diagram for condition C-7

Panel member George Edwards, on re-examination of Sandiford's diagrams for this flooding condition, found it necessary to revise them. The revised shear diagram is shown in Figure 1. The sign convention for the shear diagram is the opposite of Sandiford's, and distances are measured from the forward perpendicular rather than the aft, but the numerical values agree quite closely with his. Most of the revisions were in the moment diagram, shown in

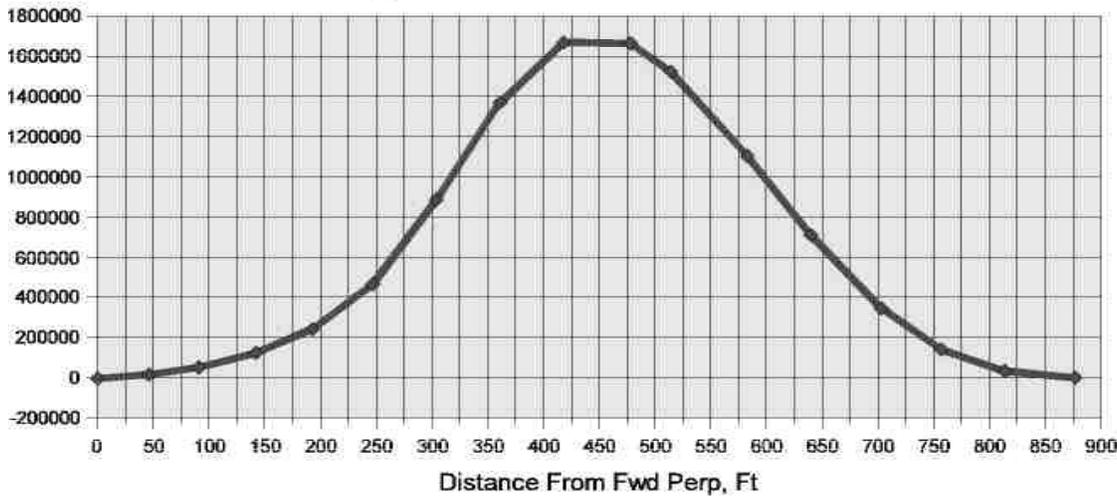
Figure 2 – Bending Moment for condition C-7

The revised moment calculations give a maximum bending moment of approximately 1.71 million ton – feet, or 4.1×10^{10} inch – pounds. This maximum occurred inside Boiler Room #2, and is much smaller than the moments originally calculated by Sandiford. (This value occurs at a point between the two highest moments shown in Figure 2.)

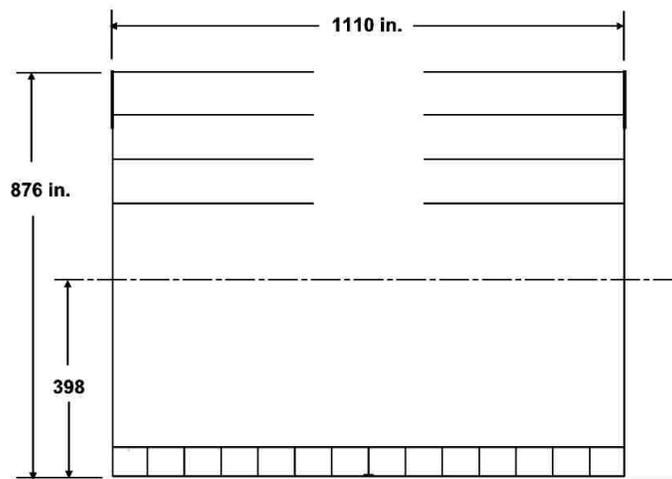
Figure 3 - Neutral axis of Titanic

The neutral axis (shown dashed) is 398 inches above the keel. The upper section modulus is 1.86×10^6 inches³, while the lower section modulus is 2.23×10^6 inches³. For the calculated bending moment, the hull girder stresses are approximately 22 ksi (tensile) at the uppermost strength deck (B Deck), and 18.4 ksi (compressive) at the keel.

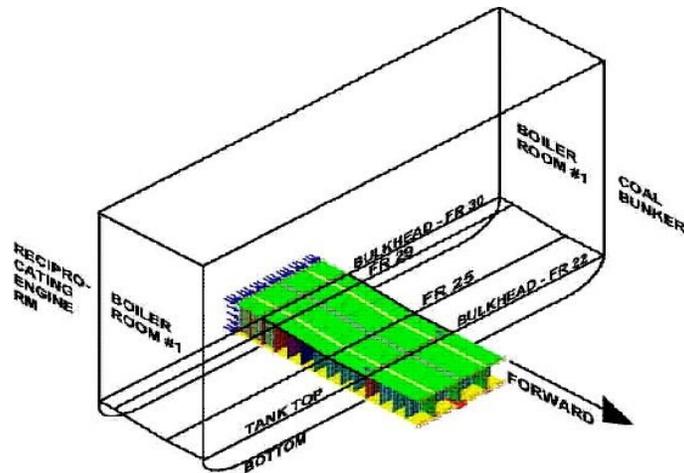
Figure 4 - Keel section model

A finite element model of a portion of the double bottom was made to investigate the behavior of this structure. In this model, the tank top sloped from 76 inches above the bottom at Frame 29 to 63 inches at Frame 25. (A number of computer runs with other configurations revealed that changes in the starting and ending points of the slope had relatively little effect on the behavior of the model.) The model is shown in Figure 4, embedded in a sketch (not to scale) showing the location of the model within the ship.

The model was made using ALGOR finite element software. Brick elements were used for the bar keel; plate elements were used for the remainder of the structure. A thickness of 0.75 inch was used for the tank top plates. A thickness of one inch was used for all other plates, except that the thickness was increased to two inches near the joint between the tank top plating and the center vertical keel, where the actual connection was reinforced with longitudinal angle irons.

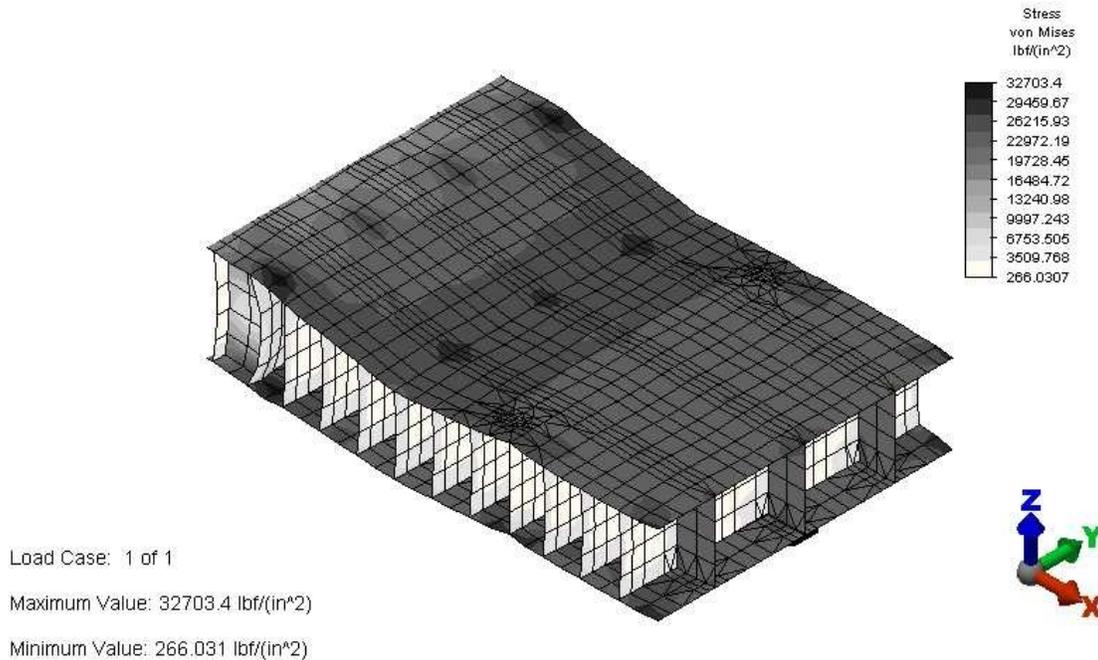
Figure 5 - Stresses at the keel transition

The average stress in the tank top and bottom plating is about 20 ksi. This is somewhat higher than the 18 ksi for which the nodal loads were calculated, largely because the original loads were calculated before the decision was made to include the extra longitudinal members under the engines.

There are a number of “hot spots” visible in the tank top plating. Some of these “hot spots” coincide with the endpoints of the “extra” longitudinal girders that make up the foundations for the reciprocating engines. The maximum stresses there are calculated to be about 32 ksi, or roughly 60 percent above the average stress in the bottom structure. For an 18 ksi nominal stress, the stress at the hot spots would be just under 29 ksi.

There are also “hot spots” of roughly the same magnitude in the tank top plating at the forward end of the transition, at the connections to the longitudinal girders.

There is substantial vertical deflection of the keel, even though there are no vertical loads on the model.

The actual stress needed to cause a failure would depend on the detail design of the structure, as well as on the quality of the materials, etc. However, the calculated stress of 29 ksi at the “hot spots” is large enough to make the triple riveted joints in the tank top plating a good candidate for the initial failure – if not at the moment when the ship reached this particular flooding condition, then soon afterward. A slightly higher stress would be needed to initiate a failure in the bottom plating, which was quadruple riveted.

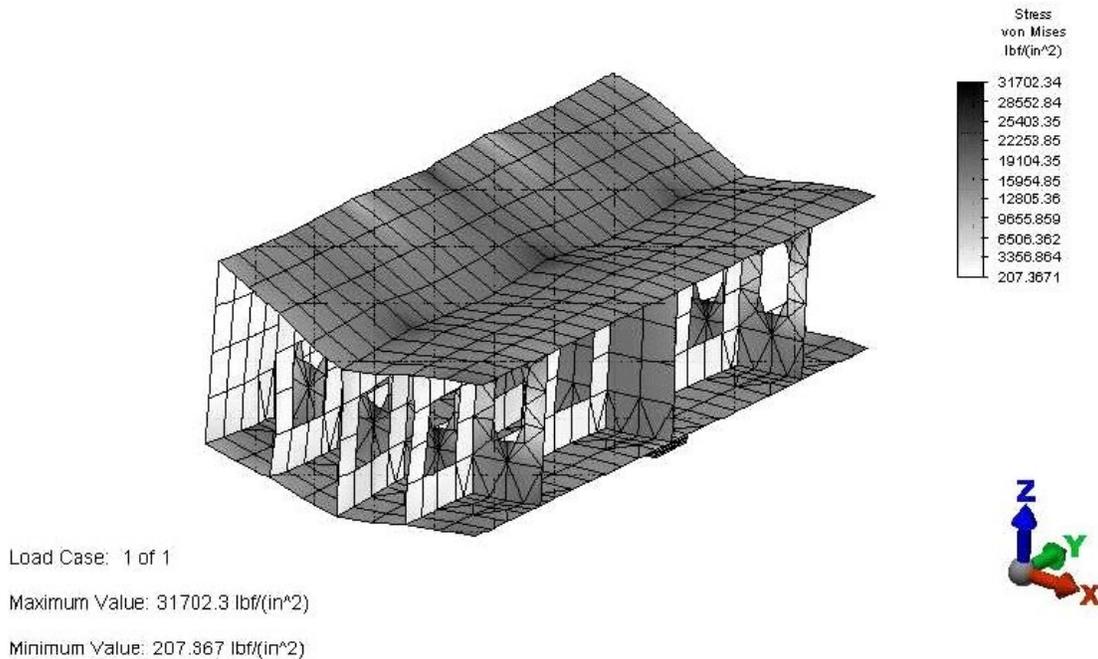
Figure 6 - Keel displacements

The pattern of "hot spots" was not substantially different when lightening holes were included. The "hot spots" still occurred above each longitudinal member at the point where the transition in double bottom depth ended. The stress at these "hot spots" was found to be about 40 percent higher than the average stress. Figure 6, in which displacements are multiplied 250 times, shows the stresses and displacements.

In this image, the average stress was somewhat lower than the nominal 18 ksi, since the loads on the lightened longitudinal members had to be decreased to avoid unrealistic deflections. The lightened members were found to be able to carry just under half as much hull girder stress as their solid counterparts. If the other stresses are adjusted to correspond to an 18 ksi average plate stress, the stress at the "hot spots" is found to be about 25 ksi.

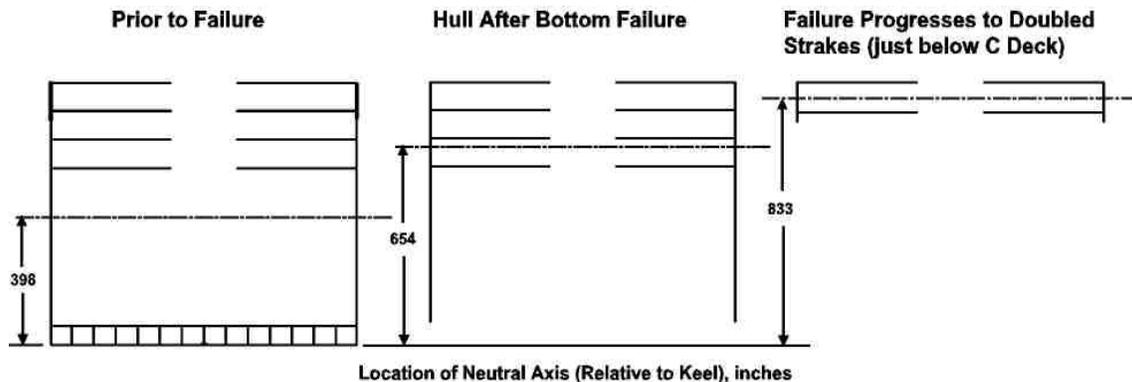
Figure 7 - Stresses and neutral axis location in the cross section

Because the side shell plates low in the ship, near the tank top, are farthest from the neutral axis, they fail before the structural members above the neutral axis. As the failure progresses upward, the neutral axis continues to move higher, eventually reaching a point between B and C Decks. Since these decks are reinforced by very strongly riveted strakes of doubled shell plating, one or both of these decks are the last to remain intact. This sequence is shown in Figure 7.

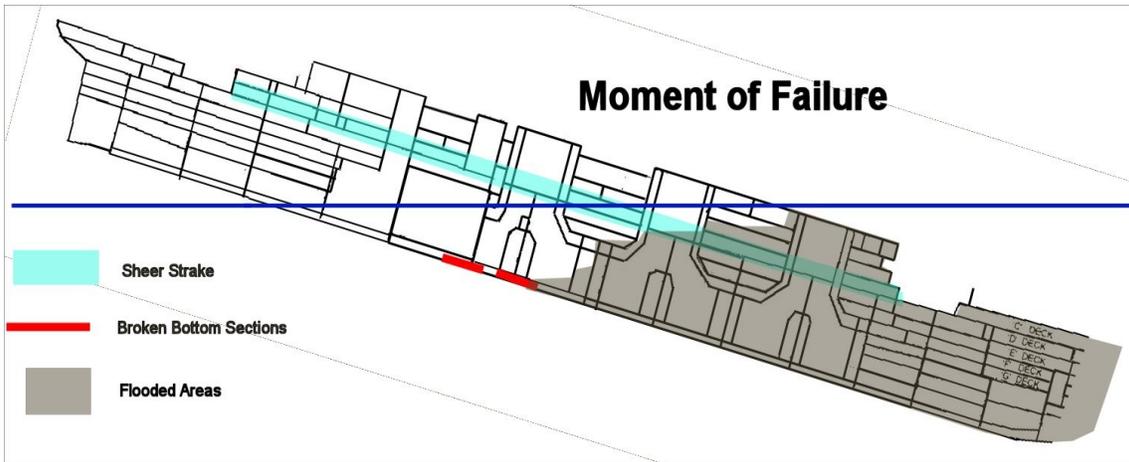
Figure 8 – Moment of Initial failure

- 3) The condition of the ship at the start of the breakup is shown (in an approximate way - trim angle and waterline location are NOT to scale) in Figure 8. Once the bottom sections are separated, the weakened hull can no longer resist the applied moment, so a structural hinge forms in the uppermost strakes and the associated deck(s). Whether by coincidence or because the superstructure provided a small amount of additional strength, the upper end of the failure is at or near the aft expansion joint in the superstructure. As the hull bends, the stern of the ship comes back down into the water. As more of the stern section gets support from buoyancy forces, the hogging moment on the hull is relieved, so the failure ceases to spread. The uppermost strength decks and side shell plates remain intact. This leaves the ship in the condition shown in Figure 9.

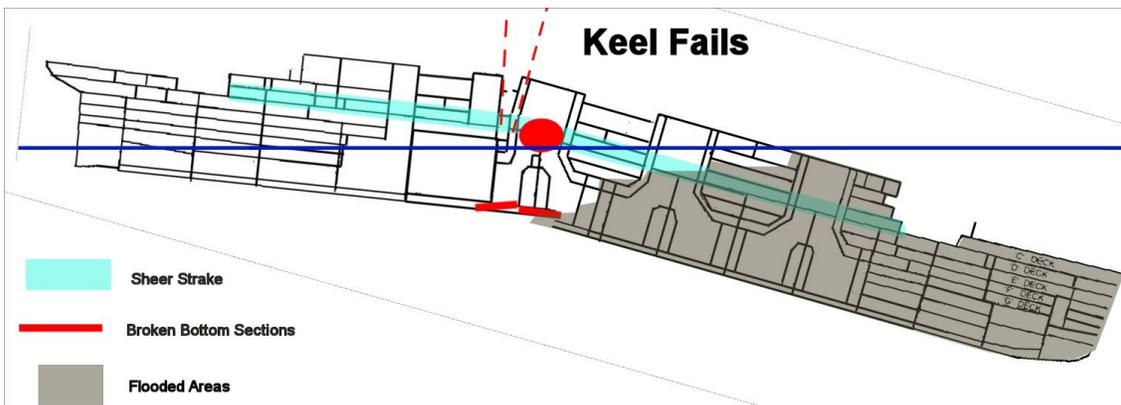
Figure 9 - Initial failure of the double bottom

This description of the ship, afloat but with her back "broken," is entirely consistent with the condition depicted in Figure 9.

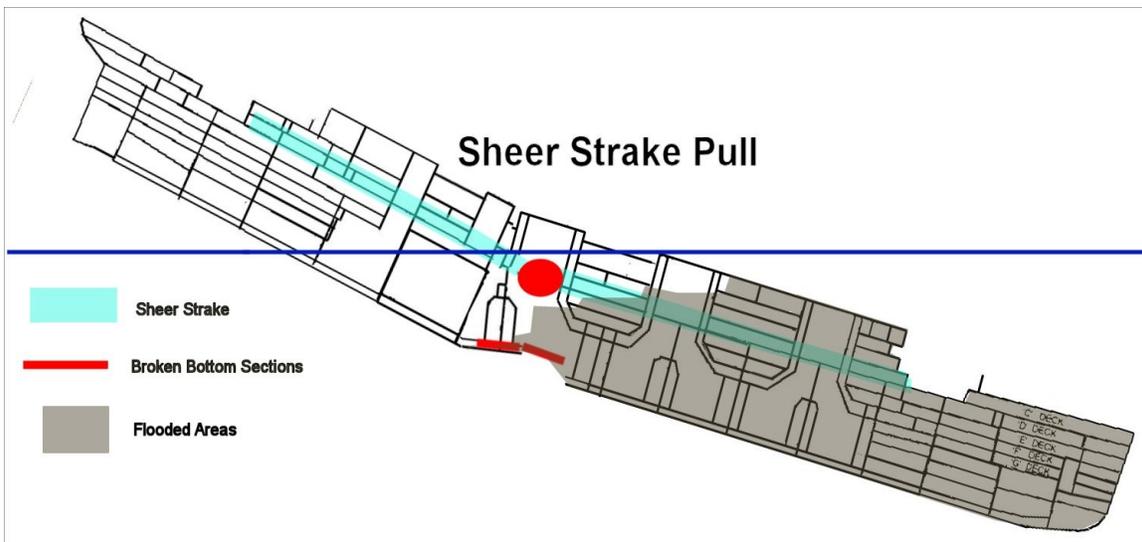
Figure 10 - The bow section pulls downward on the stern section

4) As the bow section continues to flood, it is probable that it pulls the forward end of the stern section down, as shown in figure 10. The bending moment on the remaining connections between the bow and stern sections is now reversed. Between this point in the sinking process and the time when the ship reaches the ocean floor, two things have to occur:

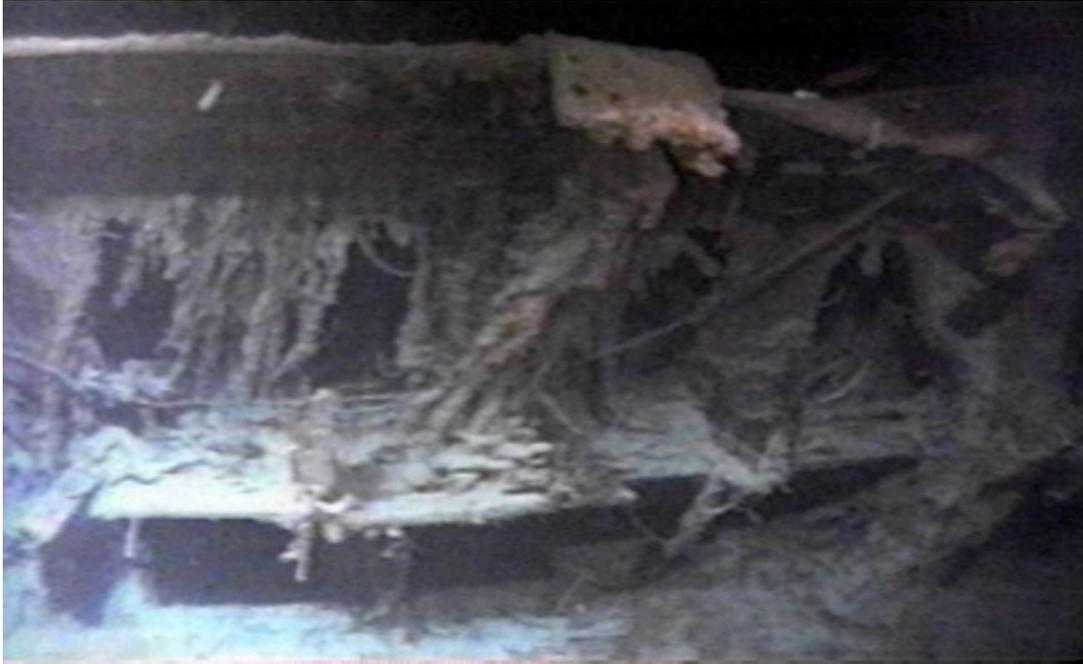
Figure 11 – S-shaped bend in keel bar

The photographs returned by the 2005 expedition show a roughly three-foot long portion of the keel, at the aft end of the aft piece, bent in an “S” shape. There is also a portion of the keel, bent in the opposite direction, at the aft end of the forward piece. Buckling calculations indicate that, given the presence of transverse frames every 36 inches, the keel could not have buckled in the conventional sense. However, the authors note that there was a sloping transition of the tank top plating between the 76 – inch depth of the double bottom under the engines and the 63 – inch depth elsewhere in the ship. This asymmetrical transition might have led to the development of stresses that would cause a bending failure in the keel.

provided the additional evidence needed to confirm the suspicions which our analyses has raised. One photograph clearly shows the bar keel bent into an "S" shape, consistent with bending under a large compressive load (Our calculations indicate that a straightforward buckling failure is unlikely, but a slight misalignment would produce a large enough bending moment to cause the failure.) This photographic evidence strongly supports the hypothesis that the failure began at or near the bottom.
